**Marine Corps Systems Command
Combat Support Logistics Equipment and Training
Systems Directorate
Quantico, VA 22134-5010**

August 1999

**Summary of Developmental Testing for the Light
Strike Vehicle / Internally Transportable Vehicle
Program**

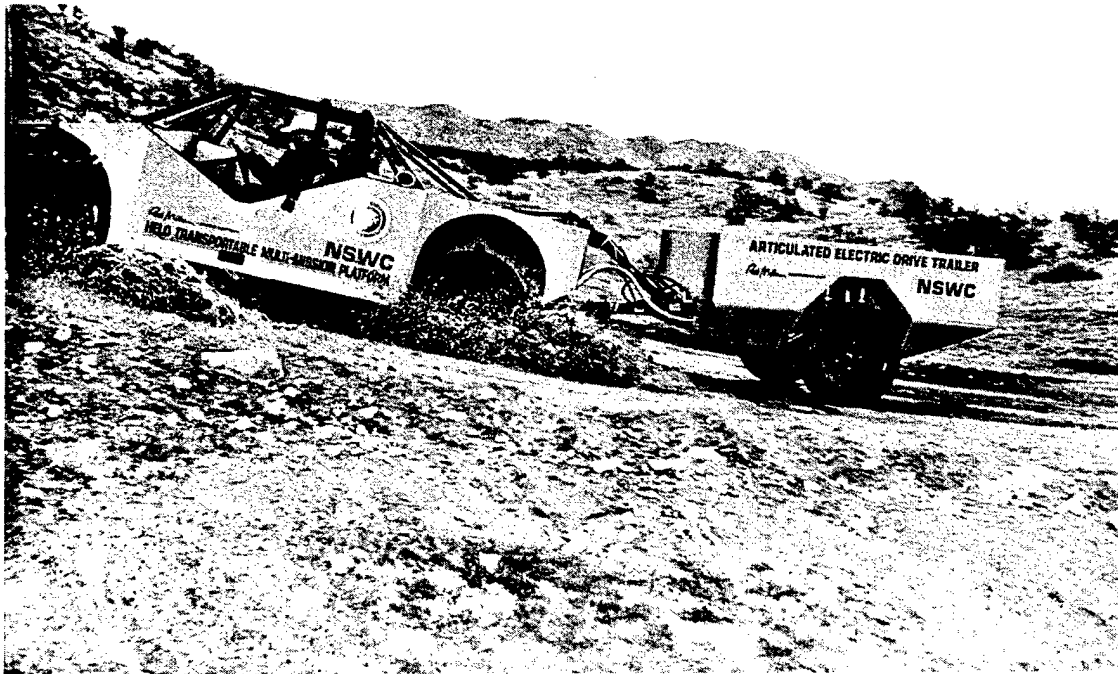
Figure 2 - Articulated Electric Drive Trailer

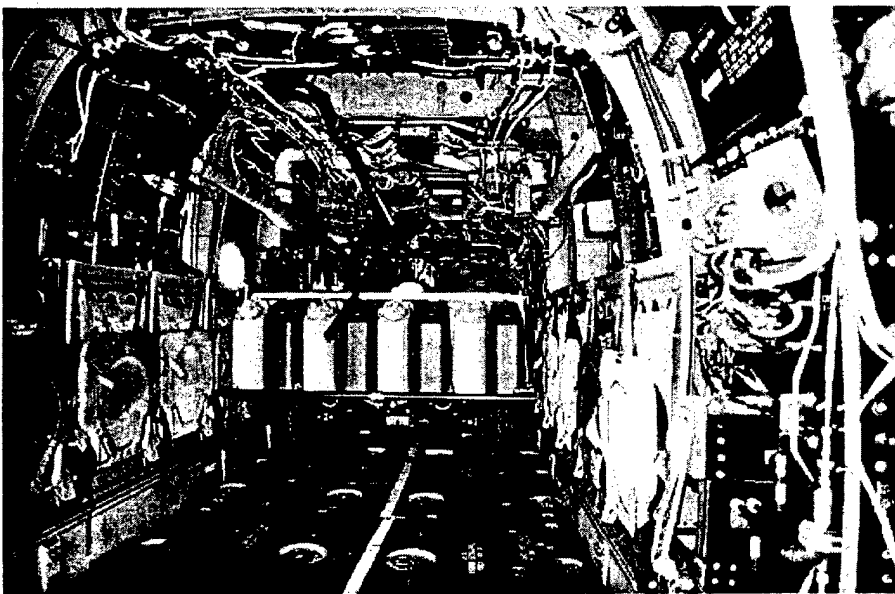
Figure 9 – Views of V-22 Fitchek #2

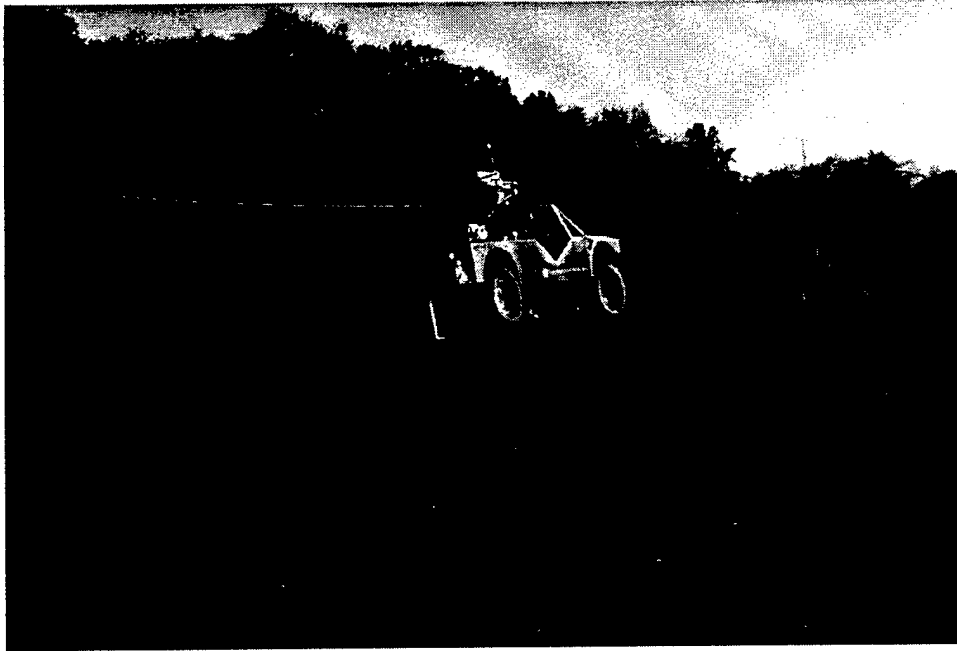
Figure 4. Rear view of HTTV transitioning from gate 2 to gate 3 of the TOP lane change course.
